# FIAT SERVICE LETTER

SUBJECT: CORRECTION TO X1/9 SHOP MANUAL, PART NO. 8061

VEHICLE: X1/9 MODEL

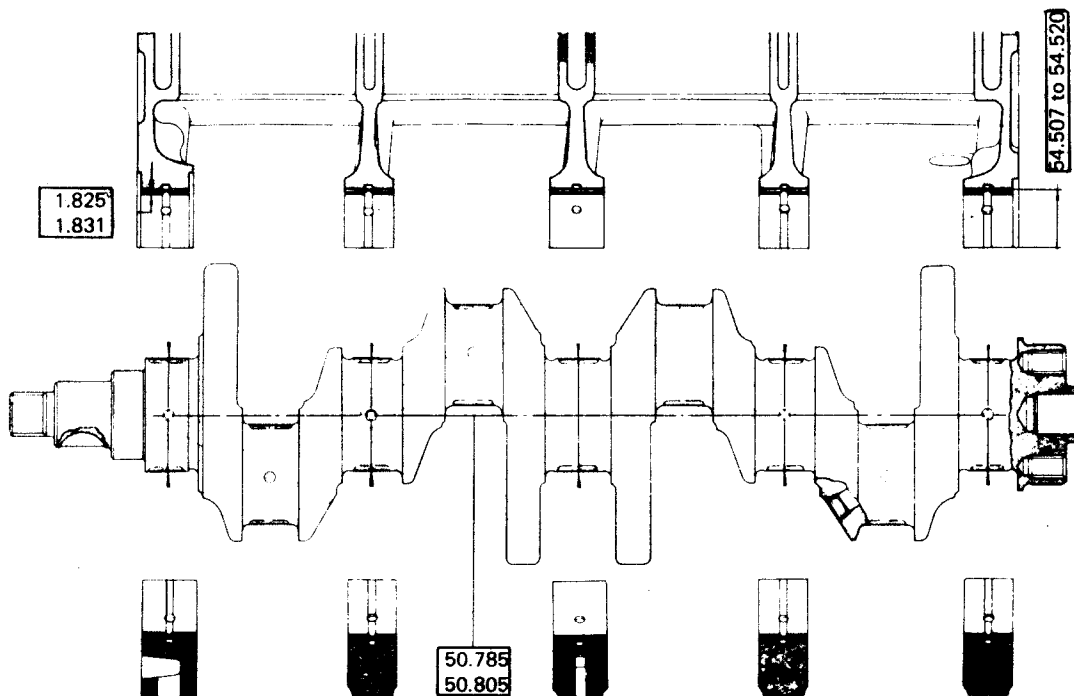
CORRECTION: The illustration pertaining to the crankshaft on page 40, Crankcase Section of the Shop Manual is incorrect.

In the illustration, the center and rear main bearing caps should be switched. The center cap does not have a lubrication groove whereas the rear cap is grooved. The illustration below has been revised to show correct bearing locations.

The illustration will be corrected in the next printing of the Shop Manual.
